DEPARTMENT OF TRANSPORTATION**DIVISION OF ENGINEERING SERVICES**

Contract #: 04-0120F4Cty: SF/ALA Rte: 80 PM: 13.2/13.9File #: 1.28**WELDING INSPECTION REPORT****Resident Engineer:**Siegenthaler, Peter**Address:** 333 Burma Road**City:** Oakland, CA 94607**Report No:** WIR-025080**Date Inspected:** 07-Jul-2011**Project Name:** SAS Superstructure**OSM Arrival Time:** 700**Prime Contractor:** American Bridge/Fluor Enterprises, a JV**OSM Departure Time:** 1730**Contractor:** American Bridge/Fluor Enterprises, a JV**Location:** Job Site**CWI Name:** See Below**CWI Present:** Yes No**Inspected CWI report:** Yes No N/A**Rod Oven in Use:** Yes No N/A**Electrode to specification:** Yes No N/A**Weld Procedures Followed:** Yes No N/A**Qualified Welders:** Yes No N/A**Verified Joint Fit-up:** Yes No N/A**Approved Drawings:** Yes No N/A**Approved WPS:** Yes No N/A**Delayed / Cancelled:** Yes No N/A**Bridge No:** 34-0006**Component:** Orthotropic Box Girder & Tower**Summary of Items Observed:**

WELDING INSPECTION REPORT

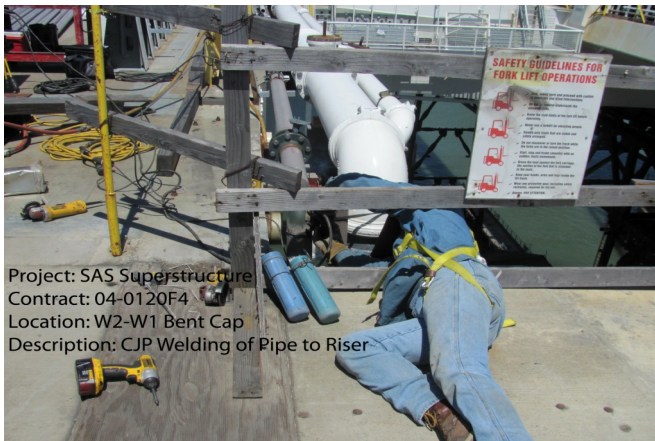
The digital photographs below illustrate some of the work observed during this scheduled work date.
